# **CYNGOR GWYNEDD**

## **ADDENDUM TO ECOLOGICAL SURVEY FOR NEW PRIMARY SCHOOL BUILD YSGOL TREFERTHYR CRICIETH**

**Dr Rod Gritten PhD PGCE CBiol MSB  
GRITTEN ECOLOGY**

**17<sup>th</sup> March 2021**

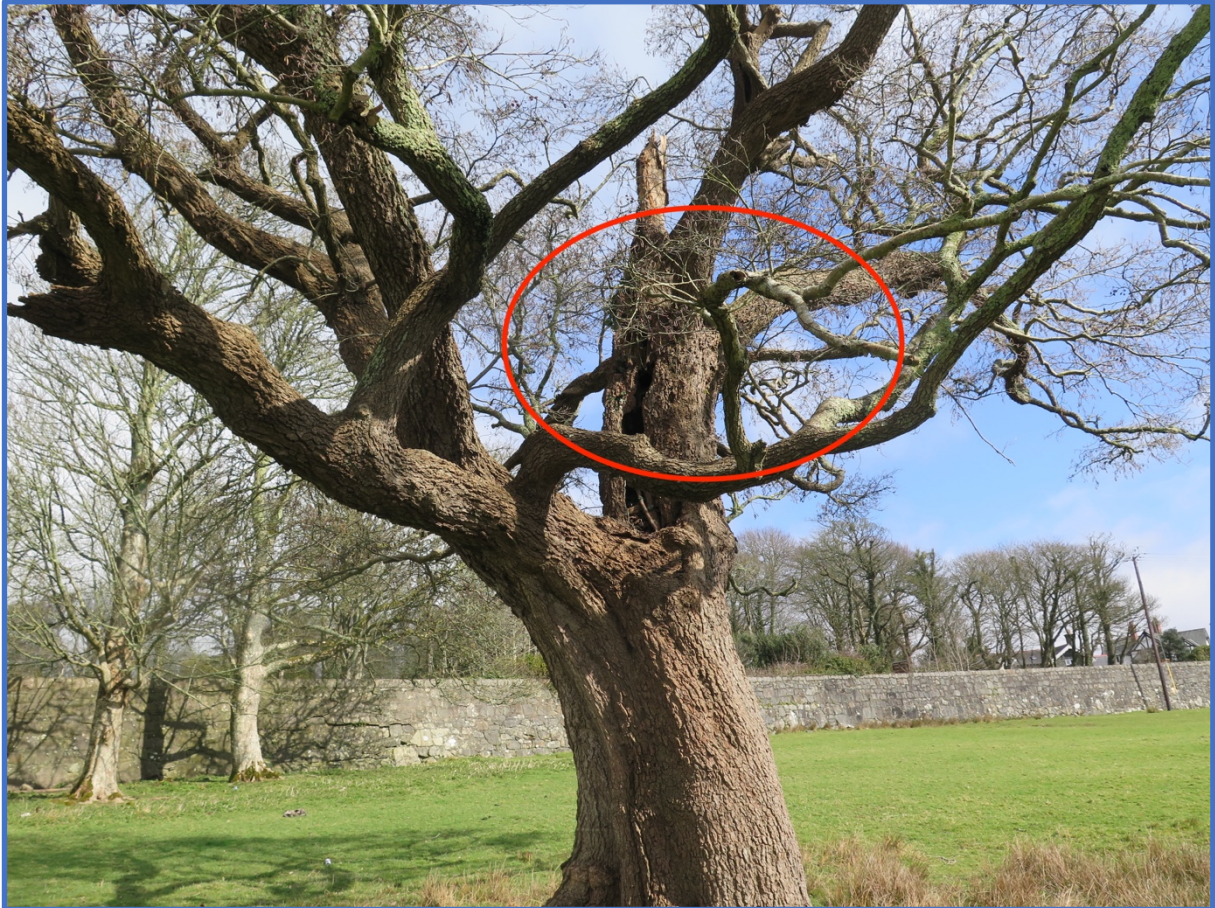
**Tree No. 4** (0059) is a veteran Alder (*Alnus glutinosa*) (**Photo 1**) that has High Potential (4) as a bat roost and also possibly as a bird nesting site. At the time of writing, it has been recommended to be felled to accommodate the proposed development. It therefore requires a detailed emergence survey as it has suitable hollows and fissures to the west.

**Photo 1: The veteran Alder with the potential bat roost ringed in red.**

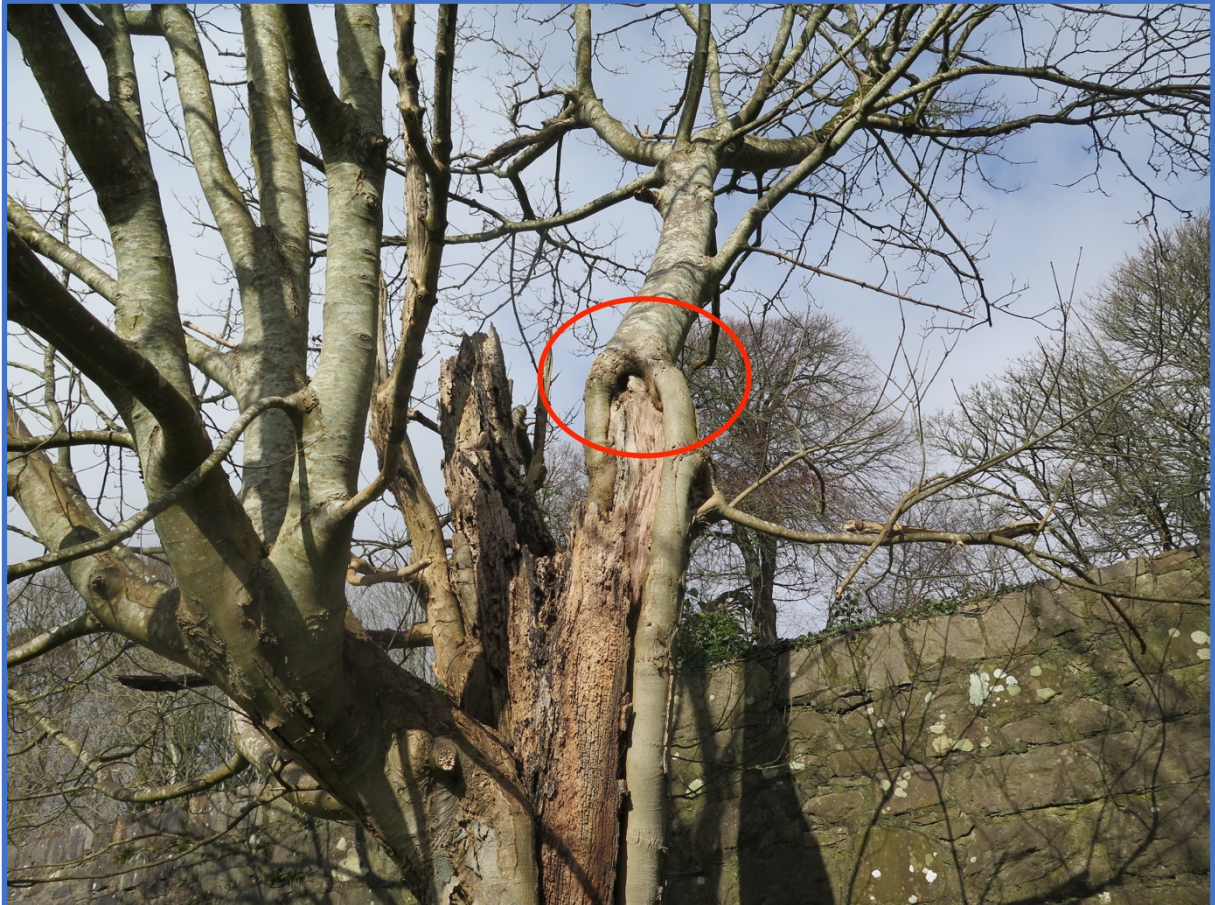
**Tree No. 5** (0060) is a poorly Sycamore (*Acer pseudoplatanus*) that is showing signs of early senescence but has High Potential (4) as a bat roost (**Photo 2**). Due to its condition, it has been recommended for felling. There appears to be a suitable roost entrance to the west.

**Photo 2: The diseased Sycamore with a potential bat roost ringed in red.**
